# METALLURGICAL INVESTIGATION OF AN EXPLOSION BONDED PLATE THAT CRACKED DURING FORMING FOR NOZZLES FOR AUTOCLAVES

## 1. Background

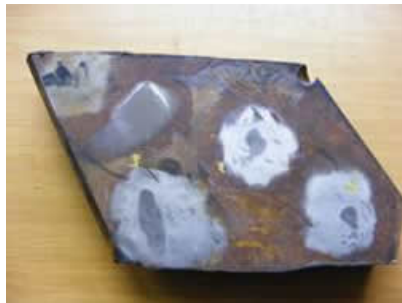
Figure 1. Visual appearance of the explosion bonded plate that shows the weld repair on the top of the plate.

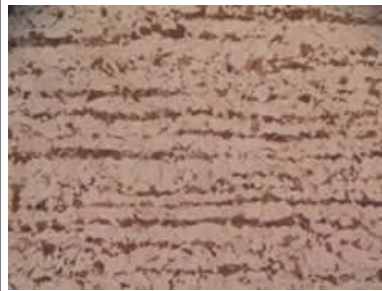
Figure 2. Micrograph of a cross section of the parent metal of the plate below the welded area.

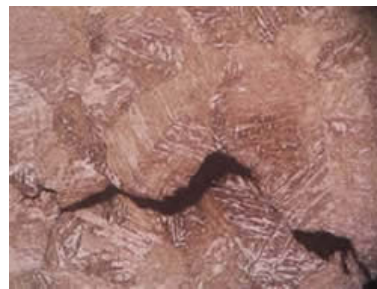
Figure 4. Micrograph of the hydrogen crack.
